ENVIRONMENTAL GEOLOGY NOTES

JULY 1971 • NUMBER 48

LANDSLIDES ALONG THE ILLINOIS
RIVER VALLEY SOUTH AND WEST OF
LA SALLE AND PERU, ILLINOIS

Paul B. DuMontelle, Norman C. Hester, and Robert E. Cole

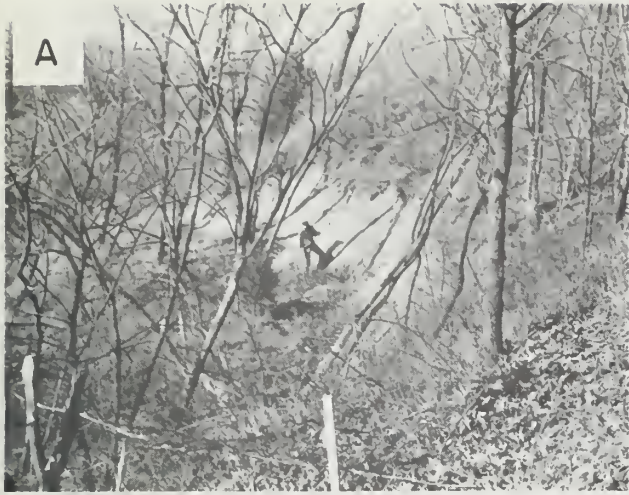
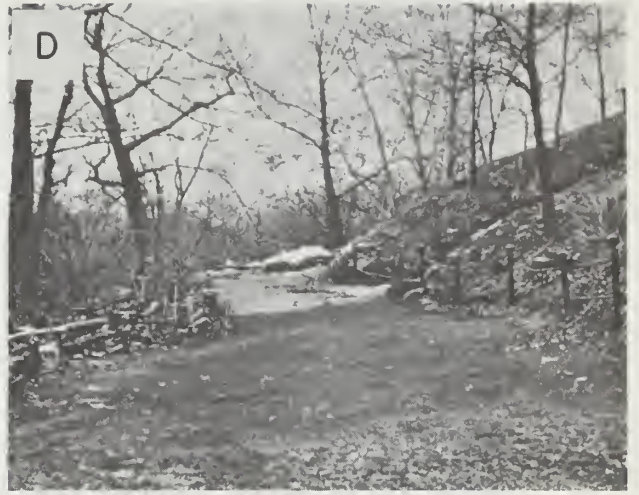
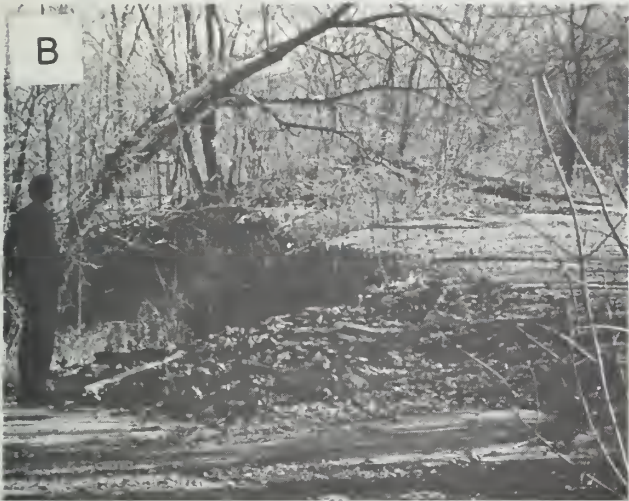
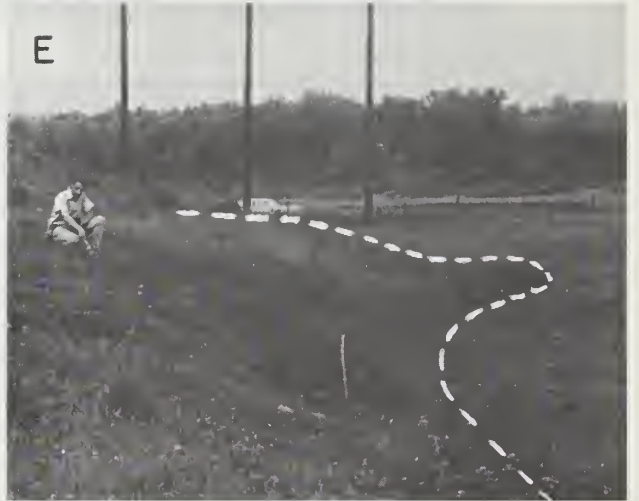
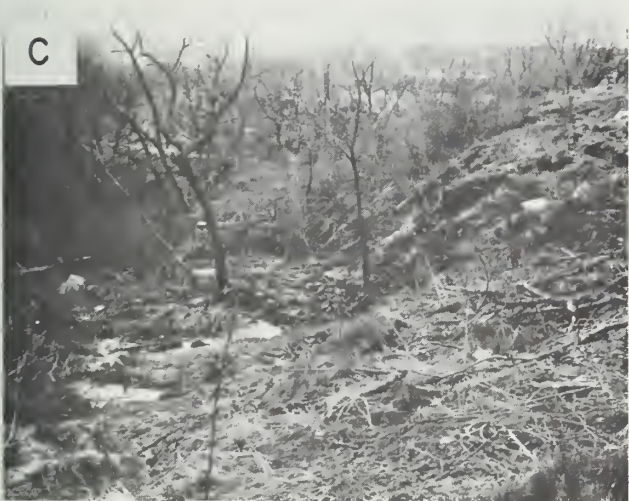
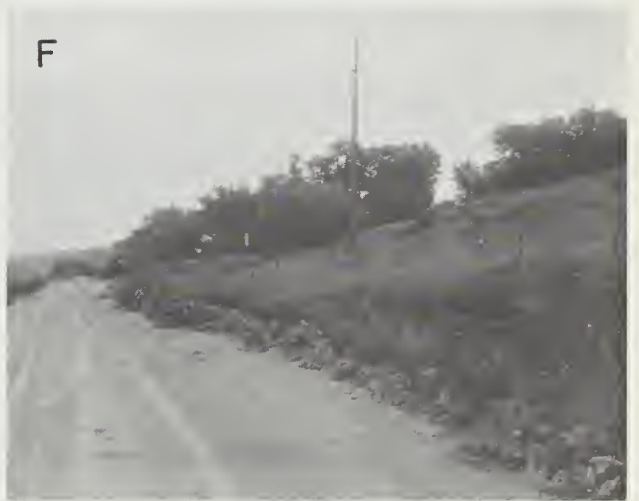
Fig. 5 - Examples of landslide activity in the La Salle-Peru area.

Downward movement of the uppermost unit from the crown area may occur relatively rapidly, causing a sharp cliff (the main scarp) several feet in height to appear in a matter of hours or weeks. If such movement takes place in a wooded, unpopulated area, such as that shown in figure 5A, it goes essentially unnoticed. On the other hand, movements affecting structures, such as the road shown in figure 5B, are noticed very quickly.

Another recognizable feature of unstable slopes is the presence of trees tilted at various angles (figs. 5A and 5C). This phenomenon has been referred to as "staggering forest." Some trees, particularly large oaks, may

The units generally do not move continuously down the slope, and, as is shown in figure 5D, some blocks may become relatively stable. Within a few years the slope may look inviting for development. However, it is practically impossible to predict how long the unit will remain stationary. Action of the natural forces that cause erosion of the landscape will eventually cause renewed movement.

- A. Slump slide in a wooded area. Note arcuate scarp (light colored outcrop) below the crown of the slide.
 - B. A road damaged by slumping activity and now abandoned.
 - C. The crown and main scarp (center and right) viewed after a rain. Ponding and poor drainage can be seen along the back slope of the first unit (center and left).
 - D. Top of a stabilized slump unit, seen here as a nearly level terrace, appears inviting for development.
 - E. Material slumping and flow (left to right) onto the valley alluvium.
 - F. Piles of creep and flow material along the road that were dug from the borrow ditch. Note crooked fence line and hummocky slope to right caused by slides.
-

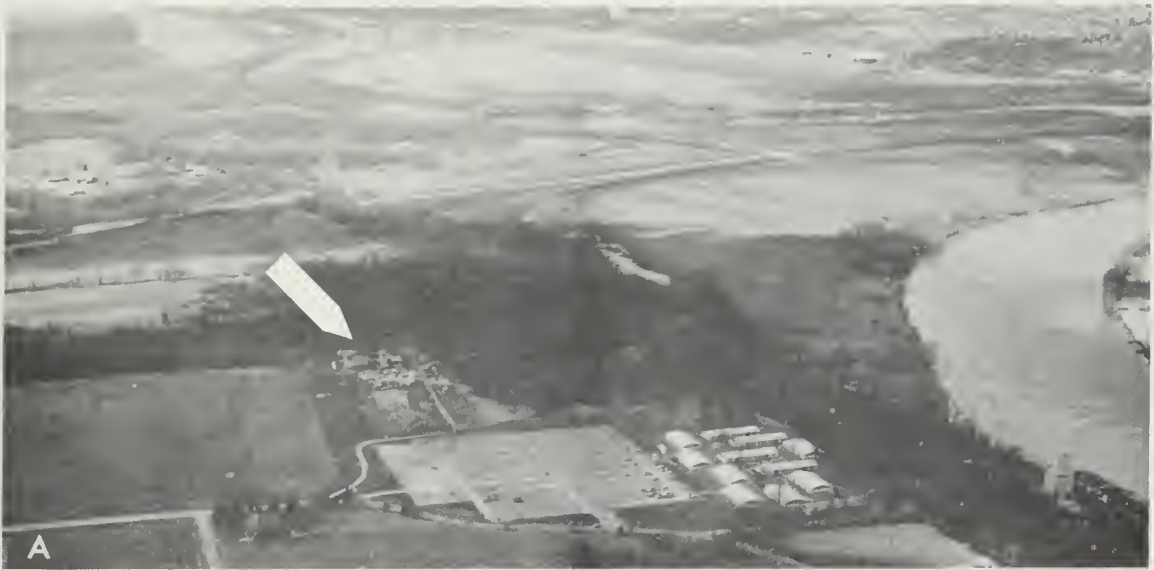
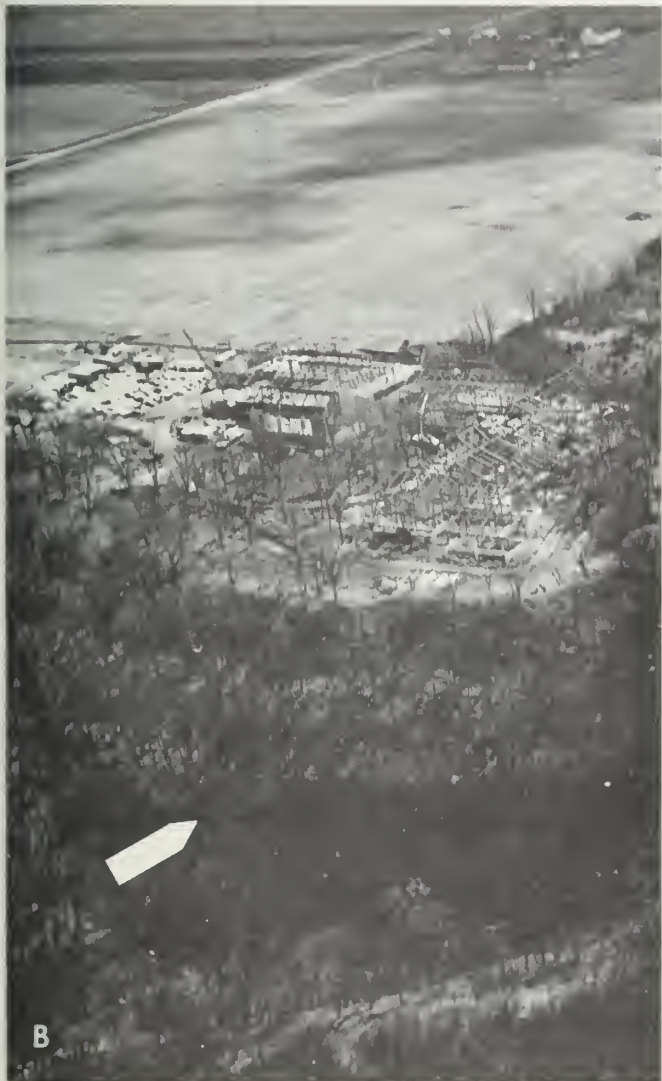
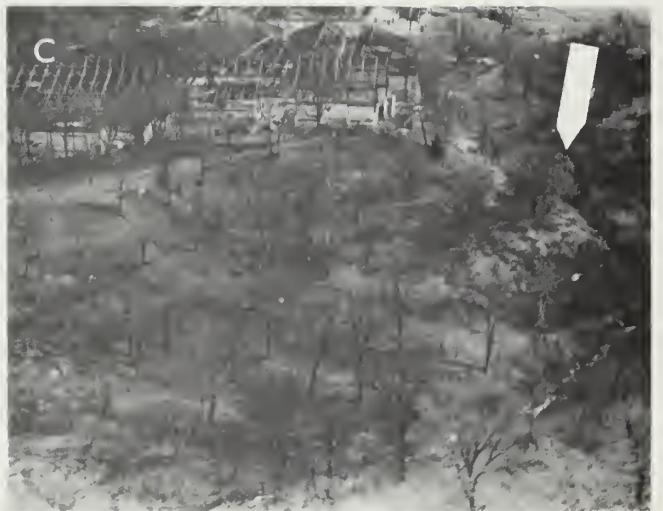
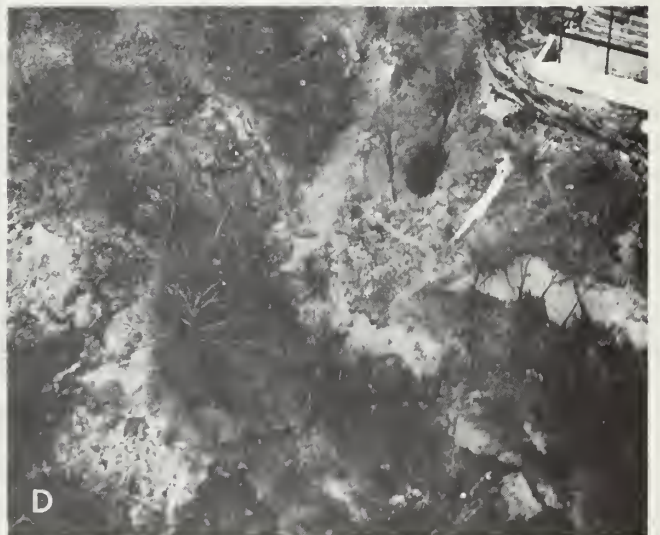
Fig. 6 - Oblique aerial photographs of landslides near Illinois Valley Community College.

Figure 6B shows the new buildings and their proximity to the adjacent tributary valley of the Illinois River. The site is bounded on three sides by tributary valleys with steep gradients. The absence of vegetation, and the presence of exposures of the shale bedrock are due to sliding. The prominent bench (white arrow, fig. 6B) along the lower part of the slope is a surface reflection of the more resistant beds of the La Salle Limestone Member. The limestone is the lowermost unit of the Bond Formation (fig. 7).

The larger scarps at this locality are about 15 to 20 feet high, and were formed by slumping blocks of soil and rock. The slump blocks extend laterally along the slope for 100 to 800 feet and form step-like benches, generally 20 to 25 feet wide. Continuity of the units is lost as the material moves down-slope, which results in an earth-creep or mudflow. Material creeping down the slope of the small valley south of the structure has completely filled the bed of the stream (fig. 6C).

- A. Illinois Valley Community College campus on the south bluff of the Illinois River Valley. Arrow points to new building construction.
 - B. Construction site from the northwest is bounded on three sides by steep tributary valleys. Arrow points to shadow caused by outcrop of the La Salle Limestone Member.
 - C. Construction site from the southwest. Scarps, slump blocks, and slides appear as irregular shapes and arcuate lines on the 2:1 slope. The large slide encroaches on the short tributary stream (arrow) south of the structure.
 - D. Construction site from east-southeast showing series of slump blocks and slides southwest of the structure.
-

The proximity of the college buildings to the unstable slopes is shown in the plan view photograph (fig. 6D). To prevent further slumping, the slopes are being kept as dry as possible. A maintenance road will circle the complex as part of the water control program for the college grounds. A storm-water system designed to intercept the downward movement of surface water will collect this water at a location east of the campus and conduct it in conduits to the valleys to the west. To prevent erosion of the slope, the drainage conduits will be extended below the limits of the outcrop of the La Salle Limestone Member at an elevation of 520 feet above mean sea level. The unstable valley slopes will be re-cut into benches, reconstructed at lower angles of repose, and compacted to develop a more stable grade.

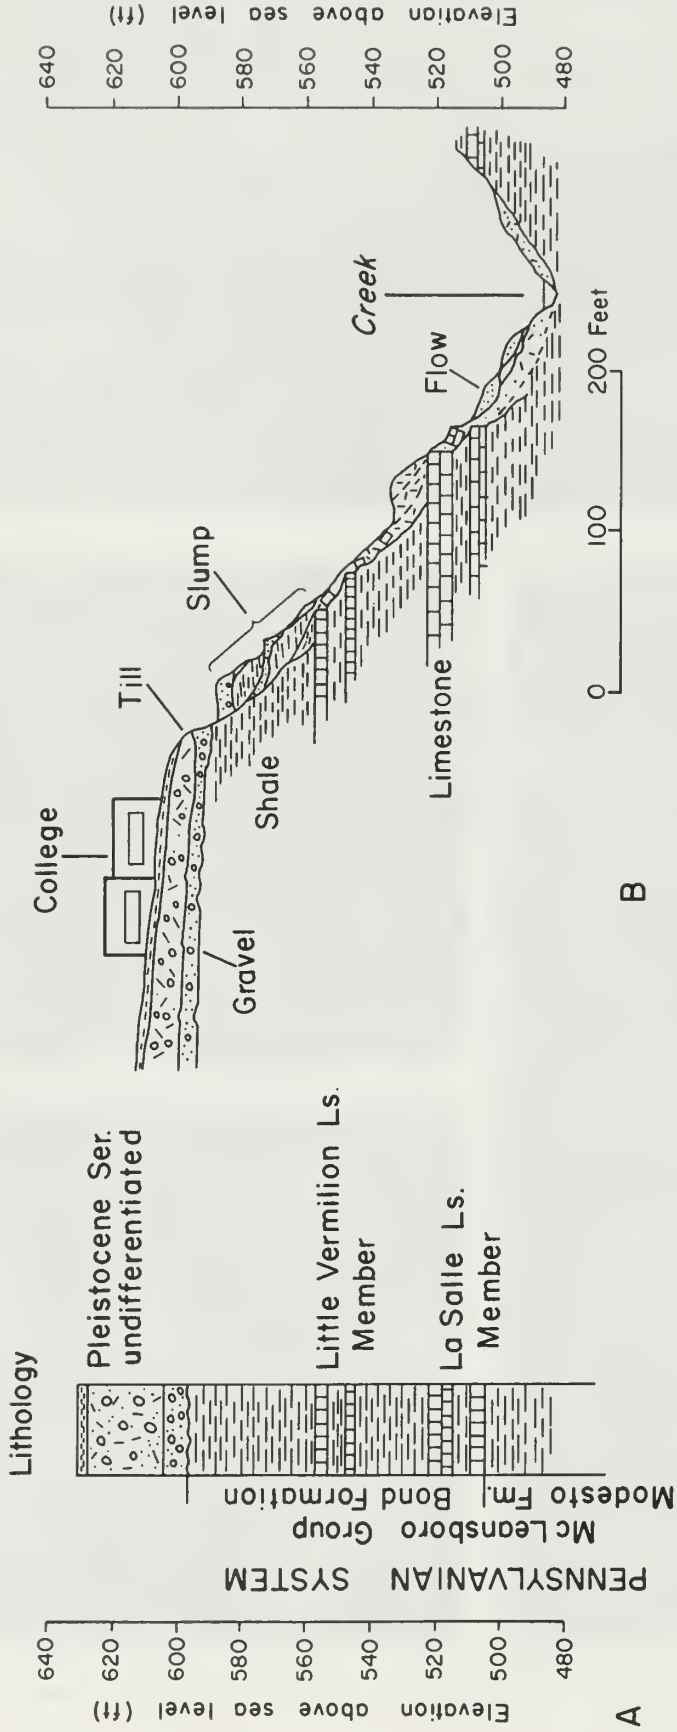
Fig. 7 - (A) Geologic column and (B) cross section of landslide in tributary valley adjacent to the Illinois Valley Community College campus. (Modified from Cady, 1919, and Willman and Payne, 1942.)

The valley profile shown in figure 7 has a vertical exaggeration of two; the true angle of slope is about 25 degrees. The slope failure pattern is schematically drawn to indicate the kinds of materials incorporated in the landslides. As observed in the field, the thin limestone units, except for the La Salle Limestone Member, are generally unable to prevent slumping. Pronounced jointing causes blocks of bedrock to loosen and slide downslope. Ground water seeps from a series of springs located at several horizons along the slopes, and springs occur along permeable bedding planes that lie above less permeable beds.

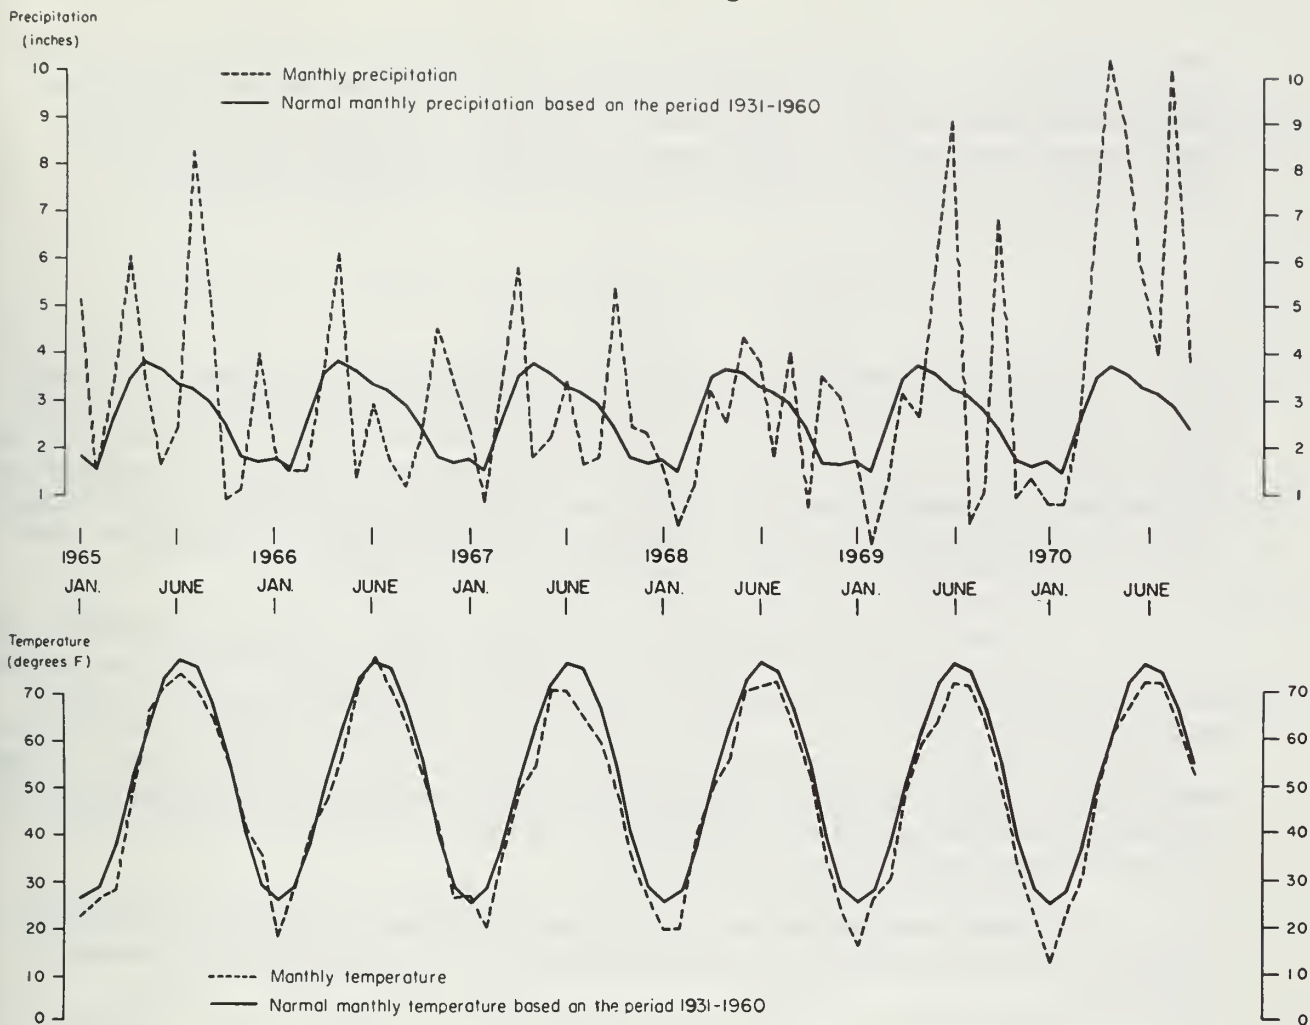
Fig. 8 - Climatological data from Peru Sewage Plant (U. S. Department of Commerce, National Oceanic and Atmospheric Administration).

Temperature and precipitation records for the past 5 years from the nearby Peru sewage treatment plant are shown in figure 8. The solid lines in both graphs represent the monthly "normal" temperature and precipitation for the plant. "Normal" is based on records collected for the 30-year period from 1931 to 1960. The dashed lines represent the actual monthly recorded average temperature and precipitation at the plant.

The temperature records show that near-normal or slightly cooler than normal temperatures prevailed during the past 5 years and the slopes were subjected to freezing and thawing. The precipitation records indicate high-intensity storms followed by dry periods generally have a frequency interval of less than a month. This pattern of precipitation subjects the bluff slopes to intermittent wetting and drying. In addition to this pattern, in some years

these regions have periods of very heavy precipitation. Precipitation occurring as a series of high-intensity rainfalls deluged the region during the spring and summer of 1970. More than 45 inches of rain fell during the 6-month period, and more than 10 inches fell during both May and September. These rains contributed to the triggering of the landslide activity.
