ENVIRONMENTAL GEOLOGY NOTES

JULY 1971 • NUMBER 48

LANDSLIDES ALONG THE ILLINOIS
RIVER VALLEY SOUTH AND WEST OF
LA SALLE AND PERU, ILLINOIS

Paul B. DuMontelle, Norman C. Hester, and Robert E. Cole

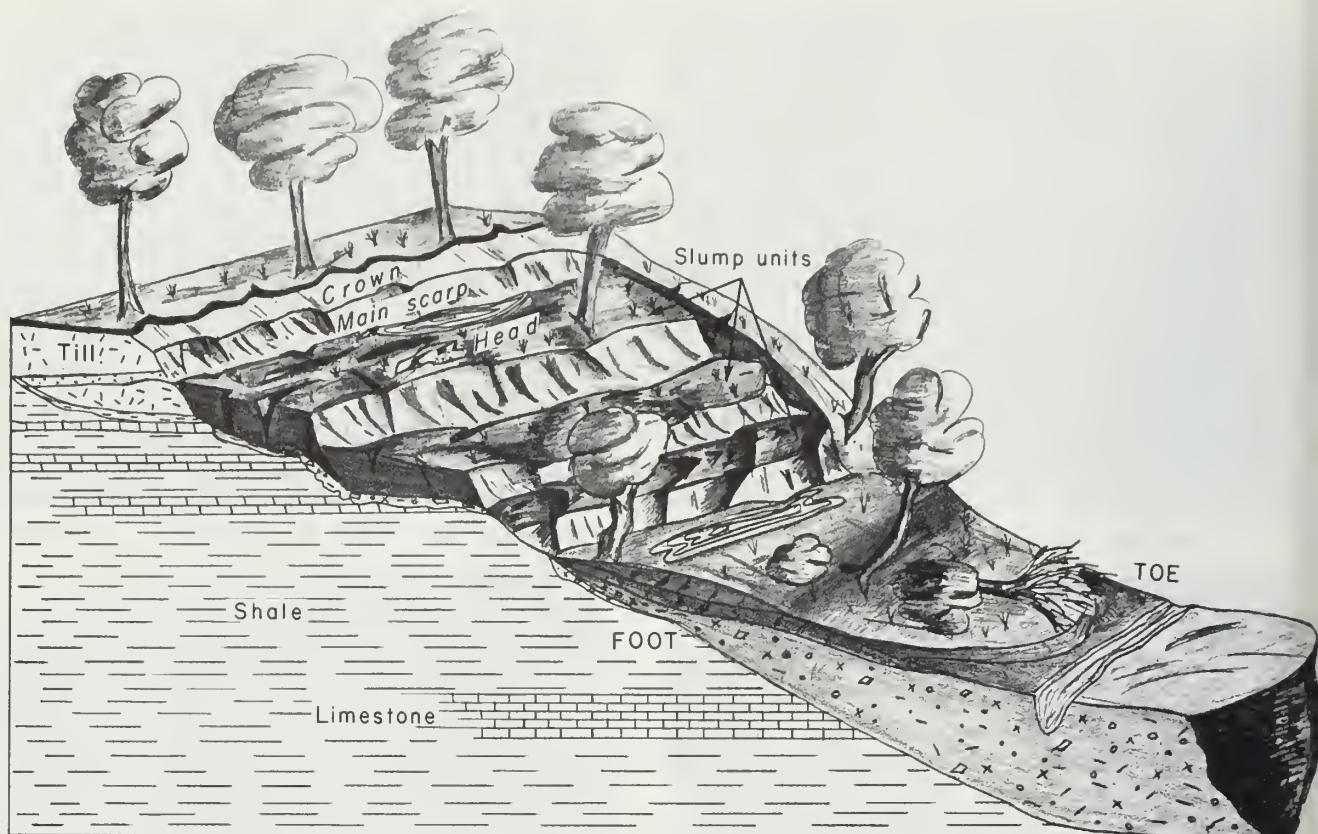
Fig. 4 - Schematic drawing of progression of landslide (modified from Fairbridge, 1968, p. 699)

of any size, moving as a unit or as several subsidiary units, usually with backward rotation on a more or less horizontal axis parallel to the cliff or slope from which it descends." Figure 4 depicts this type of slumping, which is common in the La Salle region.

As units move downslope, they tend to break up and form a tongue of flowing mixture of rock and soil, as is shown in the toe of the illustration modified from Fairbridge (fig. 4). If these areas of mudflows are active, they are often devoid of standing trees. As shown in figure 5E, the toe may flow onto the floodplain of the adjacent stream. During spring floods, these slide and mudflow materials are easily eroded or water-soaked, which rejuvenates creep. Roadbeds in the paths of these flowing materials are often buried. In figure 5F the ditch along such a road is being re-excavated to maintain proper drainage for the road. As the toe of the slide is removed, the balance or the stability of the slope is disturbed, and the cycle of landslide erosion is repeated.
